The first shipping //c part (rev.3) had a pin marked as "ground (?)" since I couldn't find a reference to where it was routed in the documentation. That pin worked fine grounded in the Atlanta Photocircuits version of the //c keyboard I tested with.

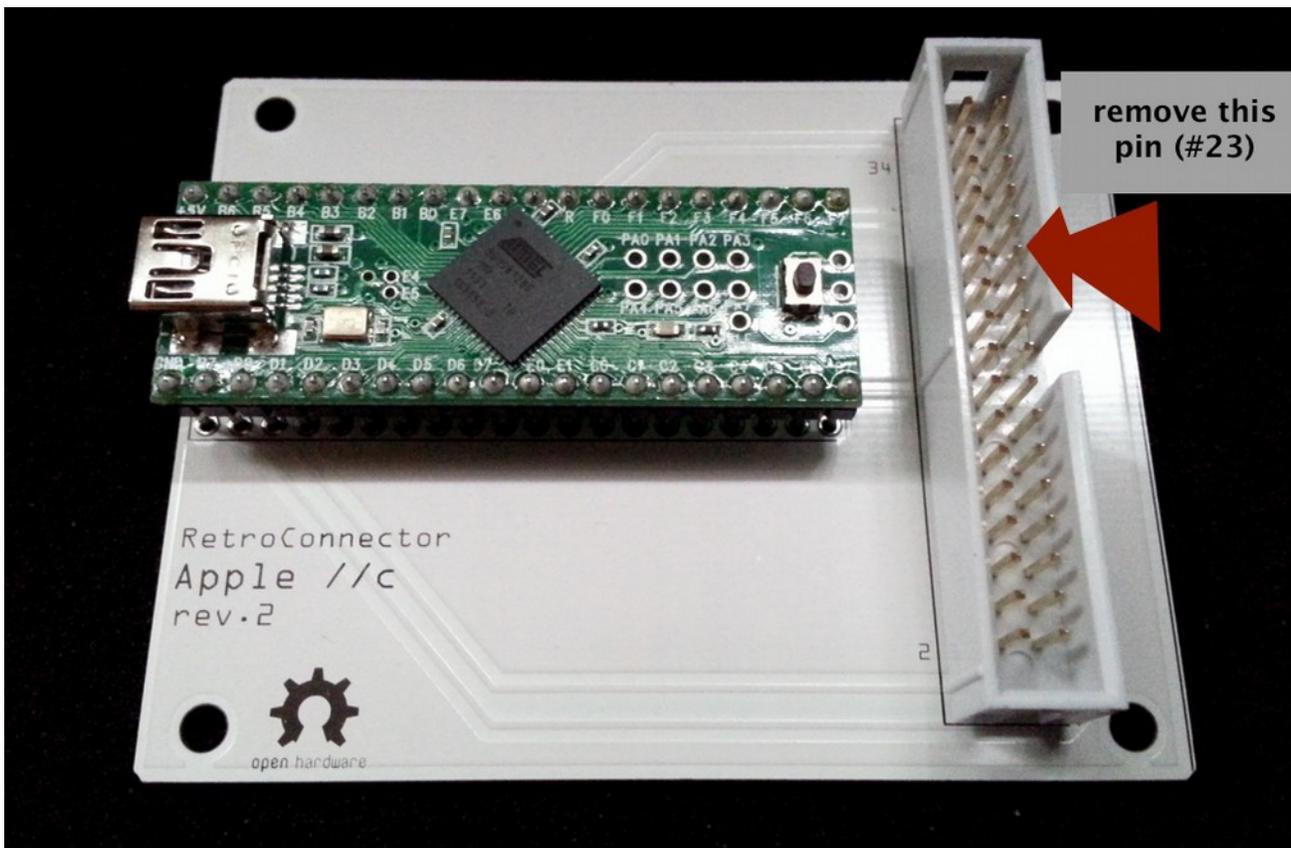
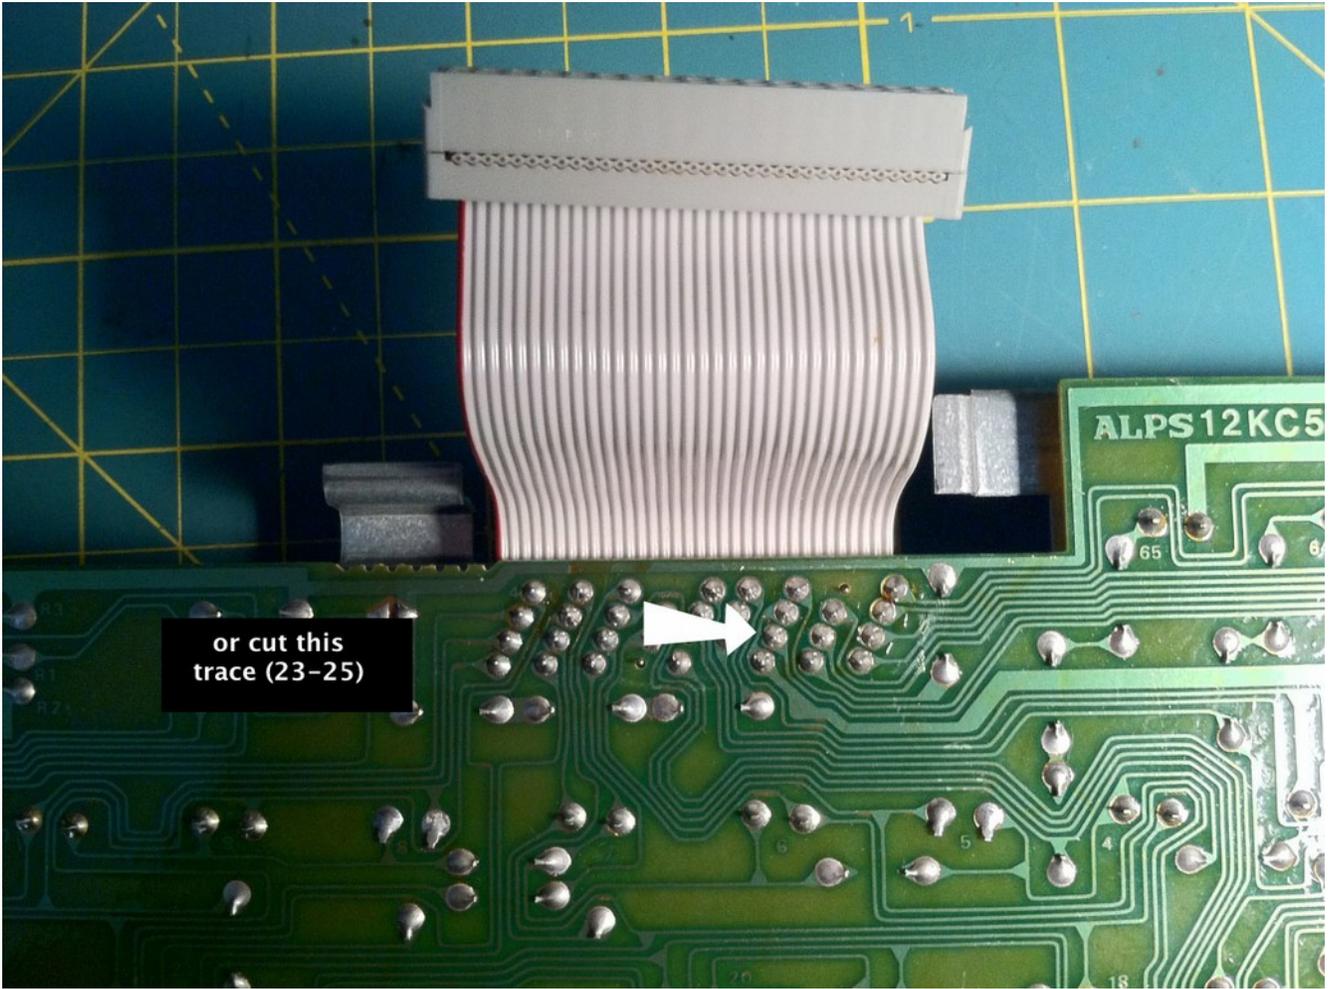
In the Alps keyboard, however, that pin shares routing on the board with 5V for the power LED indicator. So it should be 5V, not ground. This is why the keyboard draws too much power and resets the USB bus. It can't be fixed with a software update, unfortunately.

On the RetroConnector board, remove pin 23 from the header with needle-nose pliers. See below. The alternative is to modify the //c keyboard PCB, cutting the trace between pins 23 and 25.
